# Moore Bridge (SS-09): Existing Conditions & Review of Bridge Alternatives

Town of Saugeen Shores, Ontario

November 28, 2025 (Revised December 18, 2025)  
Project No. 2405129

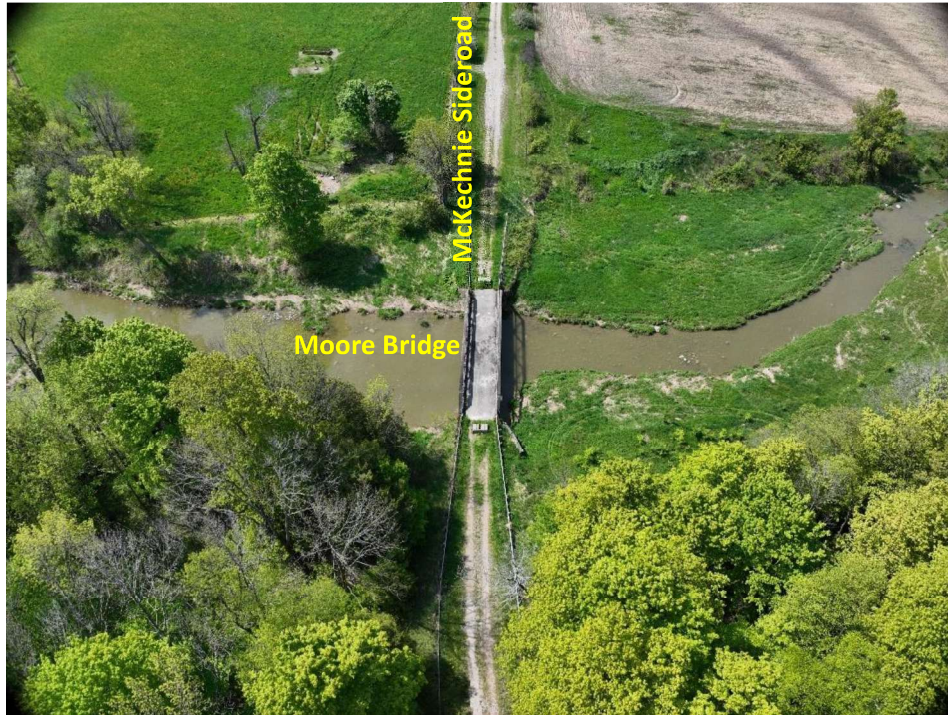
**Photo 1:** Photo of Moore Bridge showing the single lane road approaches

Moore Bridge, which is a one-lane single span steel truss structure, has been closed to vehicular traffic for more than a decade. Alternative solutions considered generally include the removal, rehabilitation, or replacement of the structure. It is important to note that the rehabilitation and replacement alternatives would simultaneously require consideration for the design and profile of the road approaches to an appropriate standard (Photo 1). The associated road works would occur within the existing 20 meter right-of-way along McKechnie Sideroad, including approximately 425 meters to the north of the bridge to Concession Road 8E and an additional 1.5 kilometers to the south to The River Road.

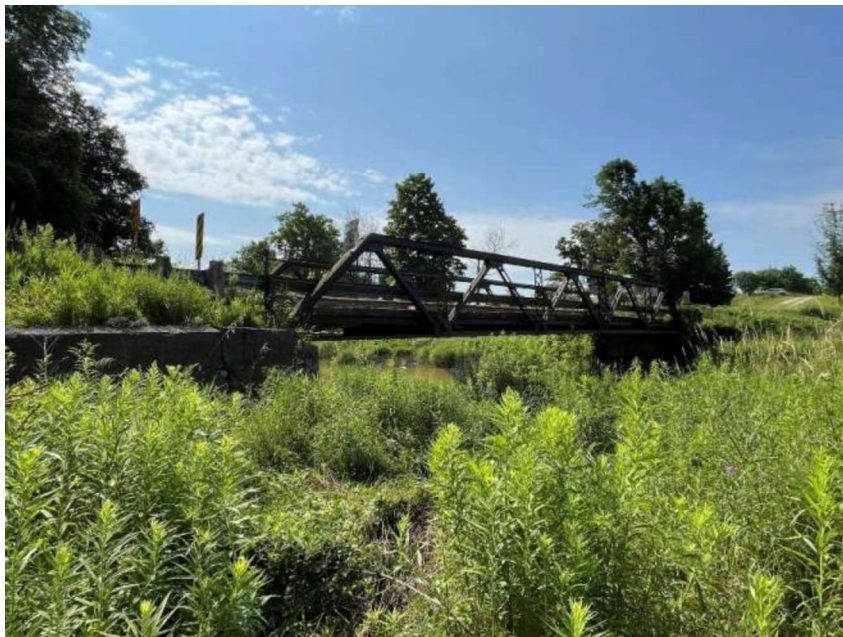
Figure 10: West elevation of Moore Bridge, looking southeast (A.S.I., 2024)

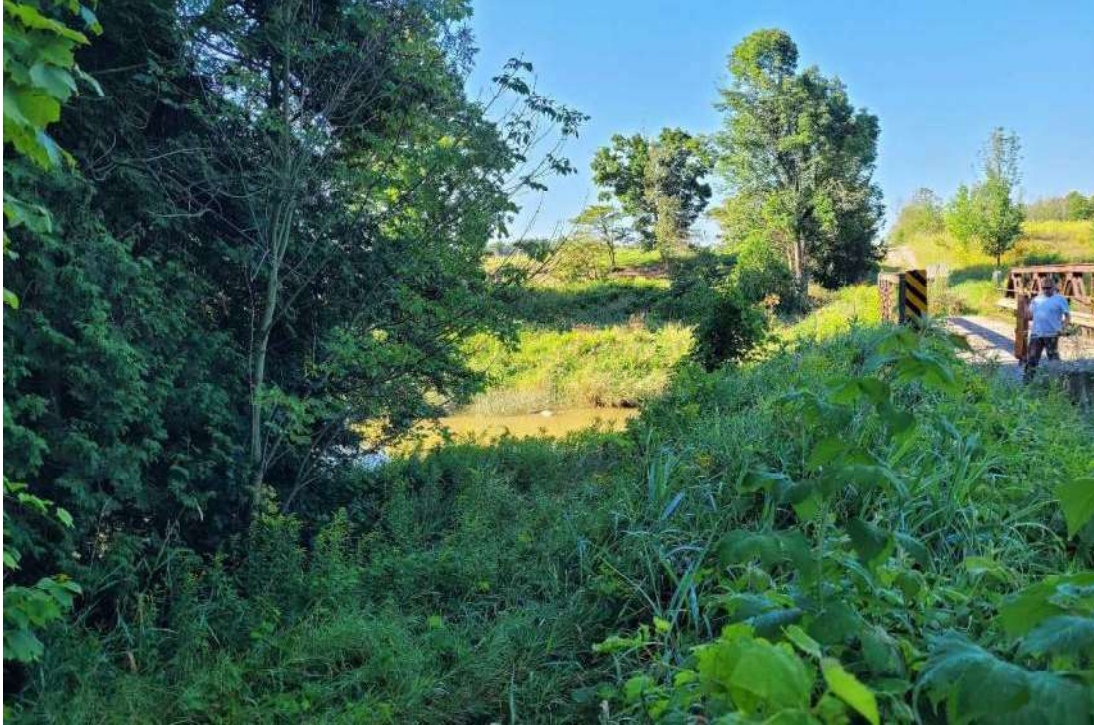
**FIGURE 3: ELEVATION OF FILLED ROAD SURFACE ON EAST SIDE OF STUDY AREA IN RELATION TO NATURAL GROUND LEVEL OF FLOOD PLAIN, FACING SOUTH**

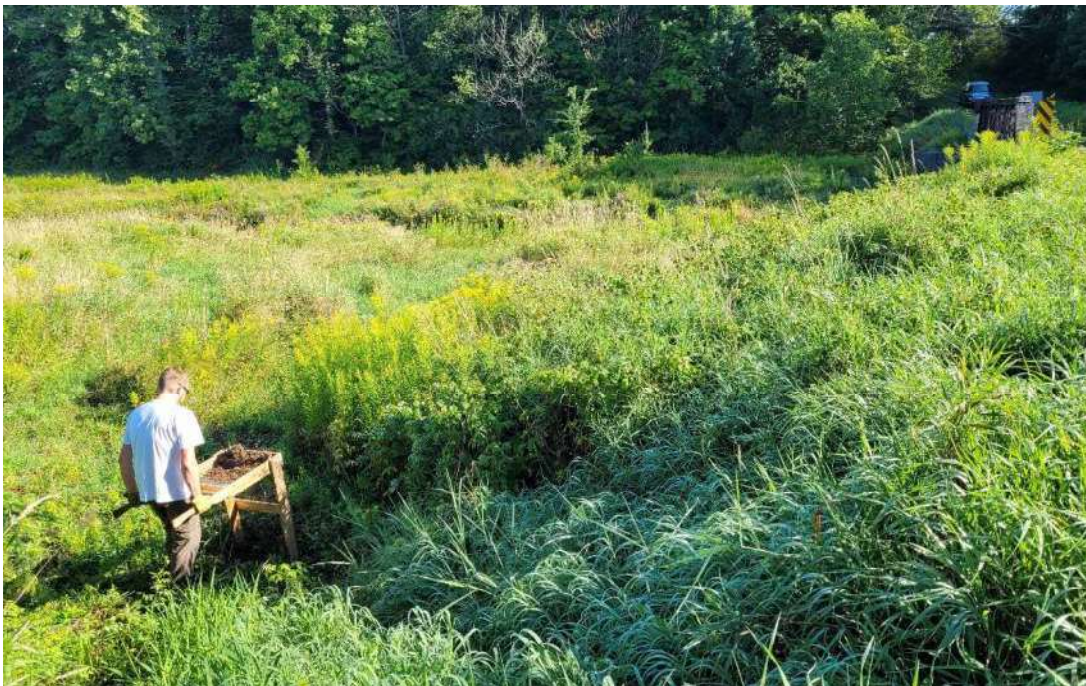
**FIGURE 4: TEST PITTING AT BASE OF ROADBED FILL, FACING NORTH**

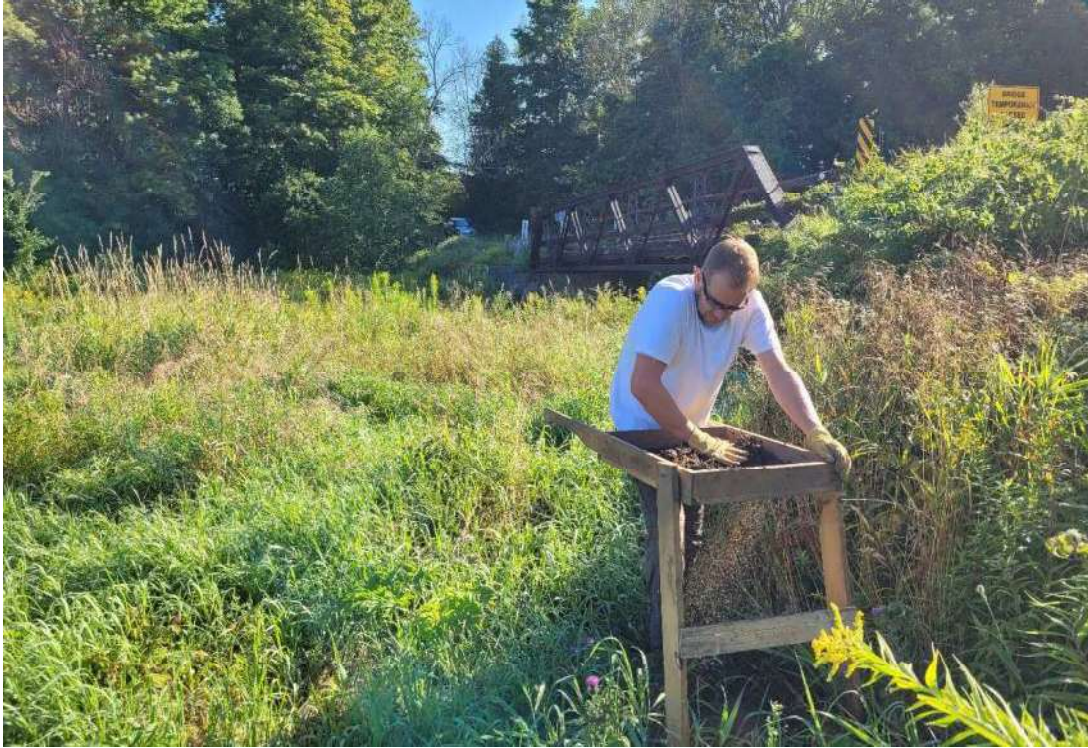
**FIGURE 5: TEST PITTING UNDISTURBED FLOOD PLAIN AT BASE OF ROAD FILL, FACING NORTHEAST**

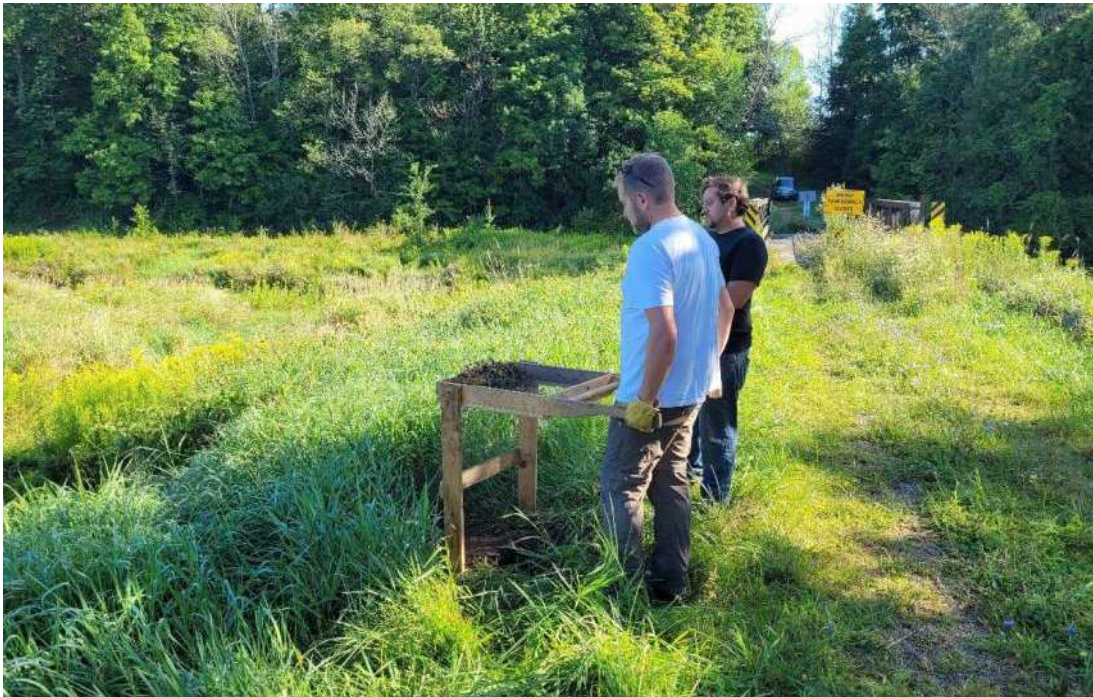
**FIGURE 6: CONFIRMING FILL VIA TEST PITTING, FACING NORTH-NORTHEAST**

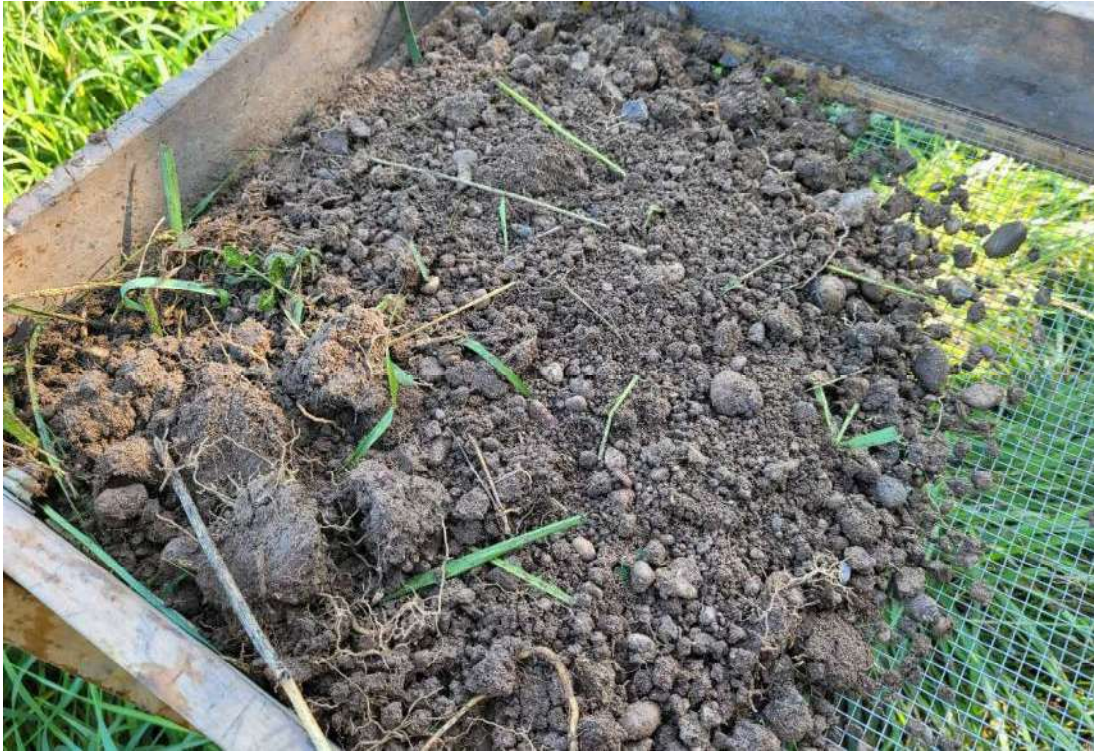
**FIGURE 7: FILL MATERIAL COMPRISING ROADBED, FACING NORTH**

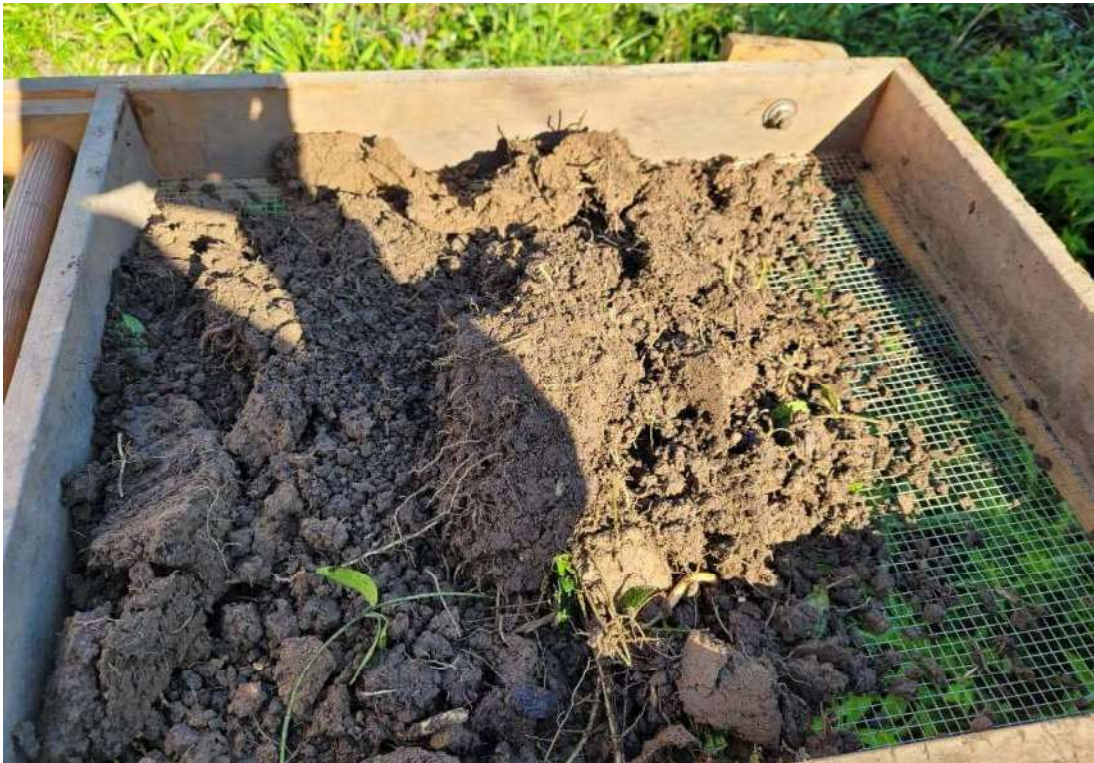
**FIGURE 8: ALLUVIAL SAND CLAY MIX OF UNDISTURBED AREA SOIL, FACING NORTH**

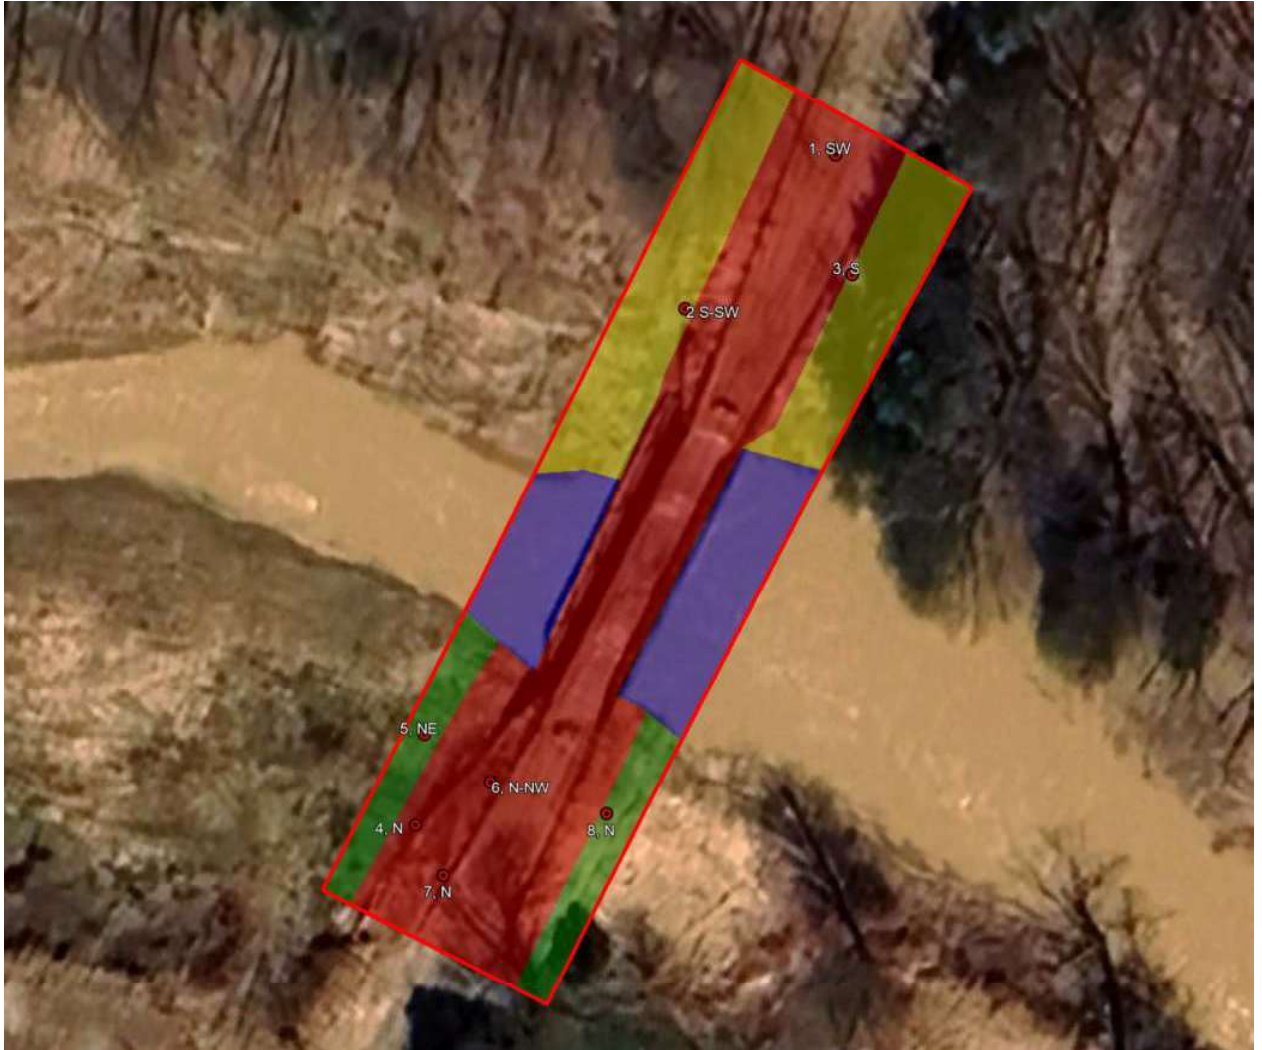
**MAP 5: STAGE 1 AND 2 ARCHAEOLOGICAL ASSESSMENT RESULTS (SCALE 1:500)**

1. Areas of previous disturbance have low archaeological potential, and no further archaeological assessment is recommended for these areas.
2. The Stage 2 test pit survey did not result in the identification of archaeological materials. No further archaeological assessment is recommended for these areas.
